CONCRETE TILE MAKING IMPACT IN HAIL COUNTRY

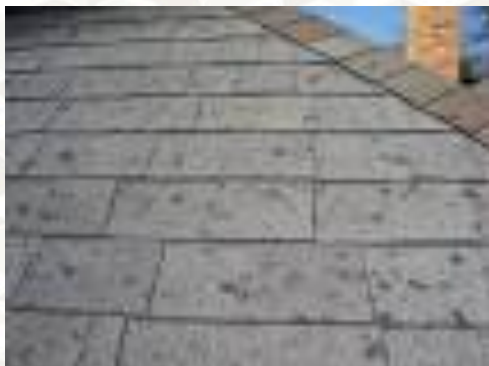
Damage to Asphalt Shingles

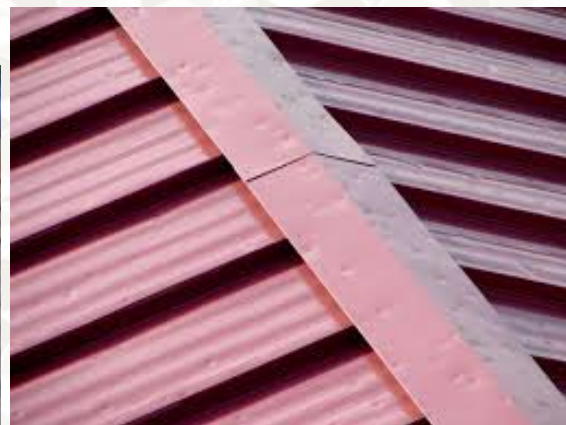
Damage to Metal Roof
